Service instruction for the 3-cup rotor Wind sensor 879.3

Replacement of the defective 3-cup rotor.

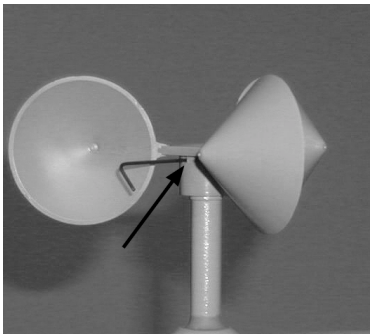
Remove the sealing wax in the bolt hole of the defective 3-cup rotor.

Dismount the defective 3-cup rotor.

Use a 1/16" Allen key.

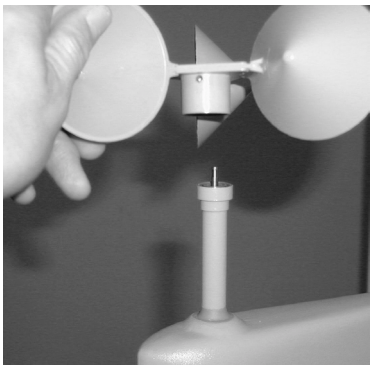
Mount the new 3-cup rotor.

Check that it has been pressed completely in position.

Tighten the securing bolt.

The bolt hole is sealed with wax or grease.

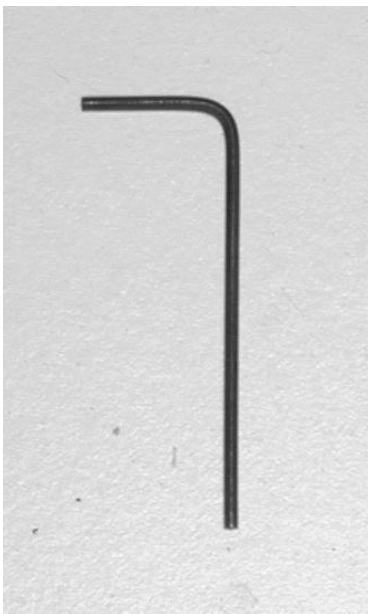
Necessary tool:
1,6 mm Allen key (1/16 inch)
